Remote Diagnosis of Overhead Line Insulation Defects

Abstract—High voltage insulation defects cause partial discharges (PD) which can be detected through the reception of radiated radio frequency (rf) impulses. The paper describes a method of detecting insulation defects on overhead lines using vehicle mounted rf measuring equipment. The equipment is based on a 4 antenna array that is directly sampled using digital equipment with a bandwidth of 1 GHz. The results are analysed by firstly estimating the time delays apparent between the 4 antennas. Secondly, using the time delays, bearing and RMS time delay error information is calculated that allows identification of the PD source. The equipment has been tested in the field on a 132 kV overhead line defect that was initially reported to a radio spectrum management agency. The results show that equipment has the sensitivity to identify the defective insulator string.

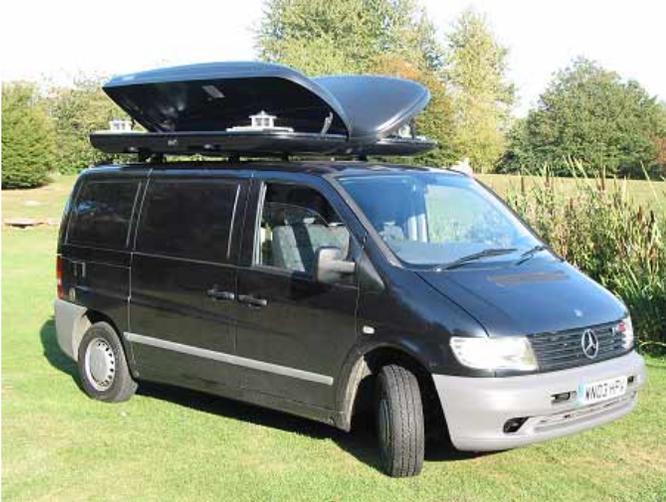
Fig 1. Photograph showing the vehicle mounted antenna array. The sampling equipment is located within the vehicle.

The equipment needed to remotely detect and diagnose defective line insulators is vehicle mounted as shown in figure 1. The equipment consists of a four channel antenna array which is directly sampled using an ultra-high-speed digital oscilloscope. A more detailed explanation of the equipment can be found in reference [1]. The salient features of the equipment are as follows:

The antenna array is fitted within two roof boxes which are mounted on a frame that attaches to the roof rail fittings on the vehicle. The coaxial connections to the four antennas are brought down the side of the vehicle and enter through a cable port. The oscilloscope (Tektronix TDS 7104) is rack mounted in an industry standard 19" rack fitted in the van interior. The rack has energy absorbing fittings to cushion the scope against mechanical shock during transport. The oscilloscope is powered with 220 Vac from a 700 W inverter that is supplied from the vehicle's 12 V battery. During initial trials of this vehicle mounted arrangement, it was determined that the operation of the inverter or vehicle engine (diesel) did not affect recording of PD impulsive waveforms. It is possible to operate the impulsive recording equipment whilst the vehicle is being driven, although all results presented here were taken with the vehicle stationary and the engine off.

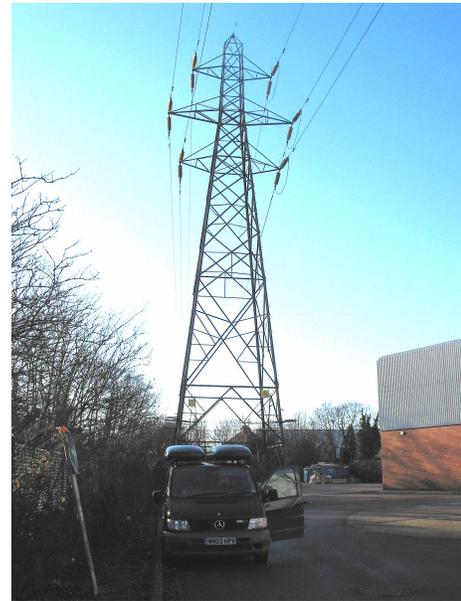
Fig 8. Photograph showing vehicle position II in relation to tower.

This analysis was made with results from vehicle position II for 2 reasons: firstly, the vehicle was closer to the tower, and secondly, the vehicle had a direct line of sight to all the line insulator strings – see figure 8, which shows a site photograph of the vehicle with respect to the tower. This procedure identifies the defective insulator string.

information of the PL4 tower and shows the cross-arm positions highly accurately. However, there are many tower base arrangements for this type and the height of the lower cross arm was not known – figure 9 shows the best estimate based on the photograph of figure 8. Figure 8 shows that each line conductor has two, horizontal insulator strings.
